# **INDOOR AIR QUALITY ASSESSMENT**

**Russell Street Elementary School  
Russell Street  
Littleton, Massachusetts**

Prepared by:  
Massachusetts Department of Public Health  
Bureau of Environmental Health Assessment  
Emergency Response/Indoor Air Quality Program  
April 2003

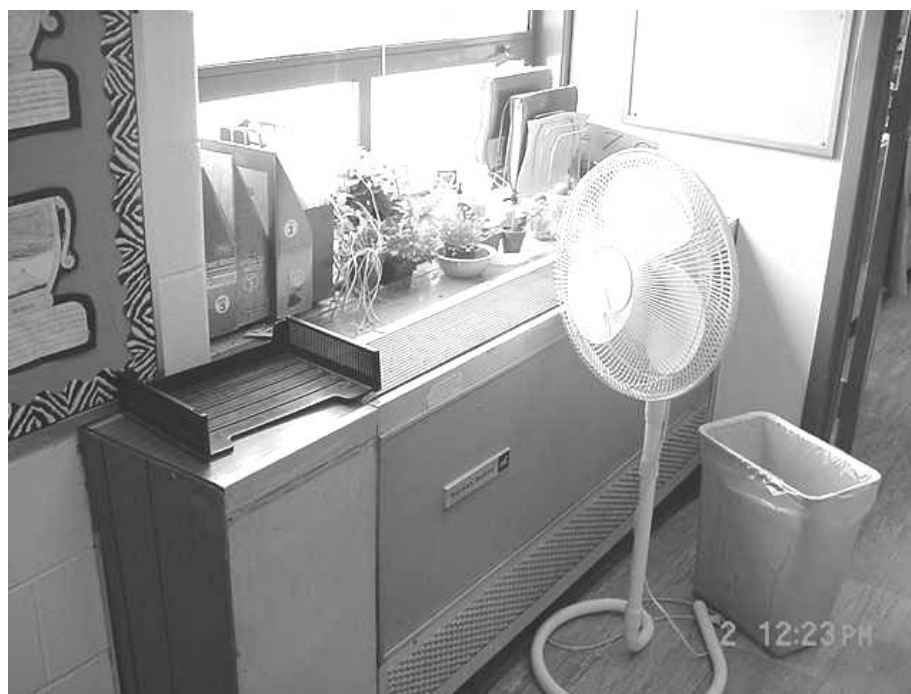
**Picture 1**

It can be seen from the tables that carbon dioxide levels were elevated above 800 parts per million of air (ppm) in twelve of seventeen areas surveyed, which can indicate a ventilation problem in these areas of the school. Fresh air in classrooms is supplied by a unit ventilator (univent) system (see Picture 1). With the exception of one classroom, all univents are at least thirty-five years old, and were installed during the original construction of the school. Univents draw air from outdoors through a fresh air intake located on the exterior walls of the building and return air through an air intake located at the base of each unit. Fresh and return air are mixed, filtered, heated and provided to classrooms through a fresh air diffuser located in the top of the unit (see [Figure 1](#)).

**Classroom Univent, Note Flowering Plants on Top of Unit Near Air Diffuser**

10. Move plants away from univents in classrooms. Avoid over-watering and examine drip pans periodically for mold growth. Disinfect with an appropriate antimicrobial where necessary. Consider discontinuing the use of abandoned sinks as planters.

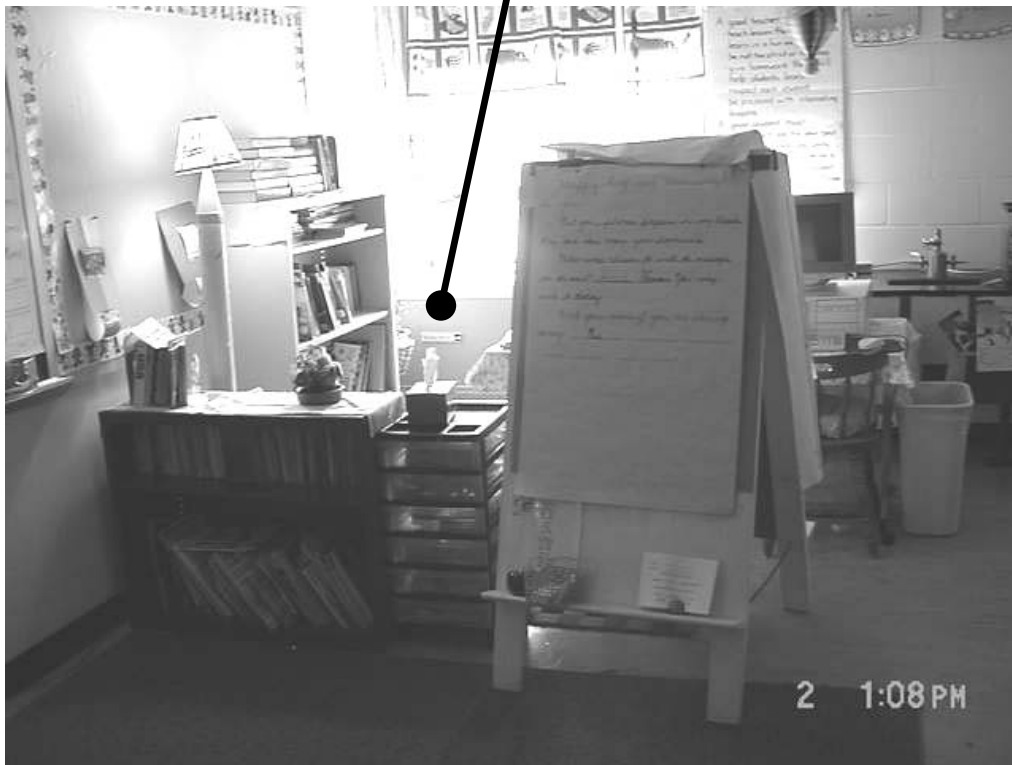
**Picture 2**

Univents were operating in all classrooms surveyed. Obstructions to airflow, such as papers and books stored on univents and bookcases, carts and desks in front of univent returns, were seen in a number of classrooms (see Picture 2). In order for univents to provide fresh air as designed, intakes must remain free of obstructions.

**Items in Classroom Obstructing Airflow of Univent**

4. Remove all blockages from univents and exhaust vents to ensure adequate airflow.
5. Install passive vents in doors of PT/OT room. Consider installing a local exhaust vent in the exterior wall to provide air circulation.

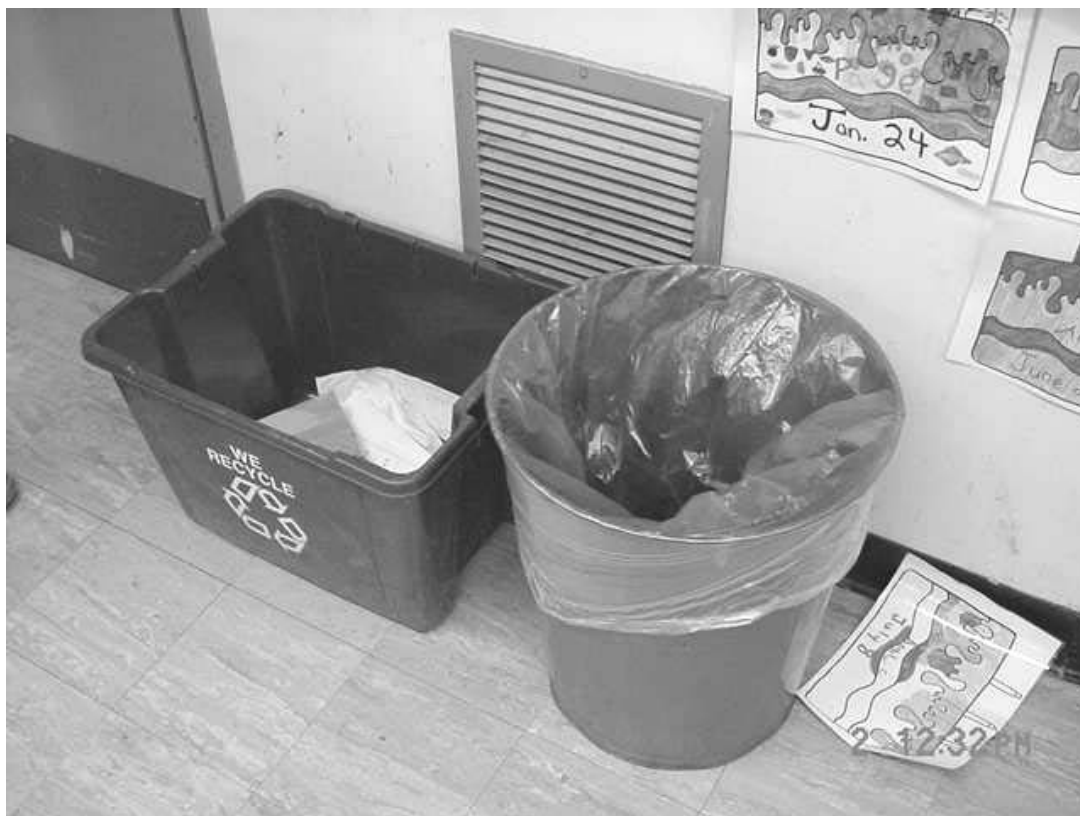
**Picture 3**

Exhaust ventilation in classrooms is provided by a mechanical system. The exhaust system in each classroom consists of ducted, grated wall vents, which create draw of air through rooftop motors. Exhaust ventilation was functioning in all classrooms surveyed. A number of the vents were blocked by desks, bookcases, shelving and in some cases open doors (see Pictures 3 & 4). The location of exhaust vents in some classrooms can also limit exhaust efficiency when the classroom hallway door is open. When a classroom door is open, exhaust vents will tend to draw air from both the hallway and the classroom (see Picture 5). The open hallway door reduces the effectiveness of the exhaust vent to remove common environmental pollutants from classrooms. As with the univents, in order to function properly, exhaust vents must remain free of obstructions.

**Classroom Exhaust Vent Partially Obstructed**

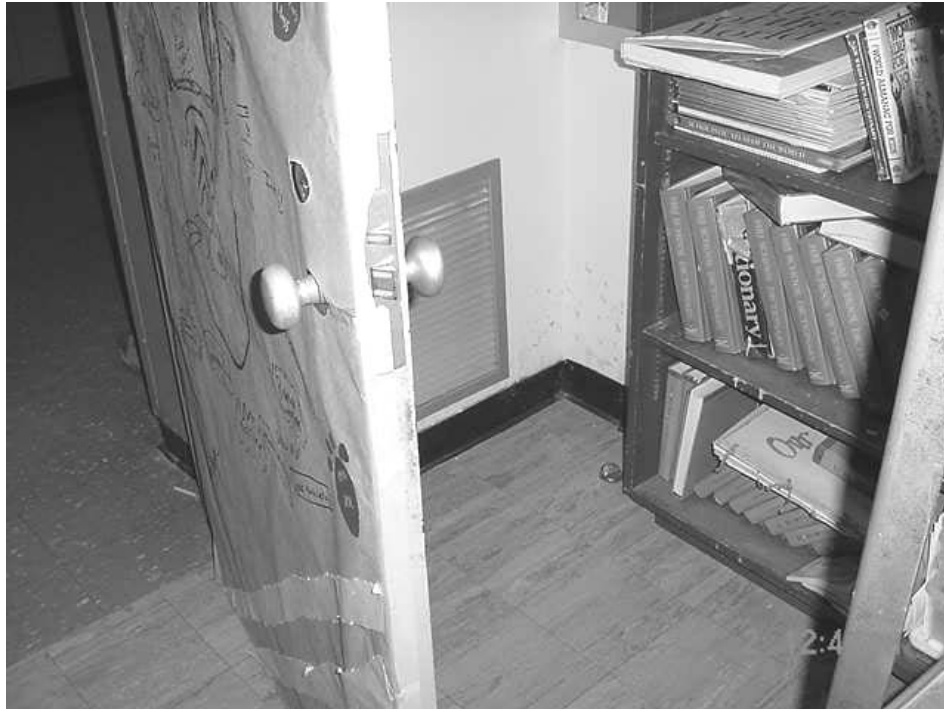
**Picture 4**

**Classroom Exhaust Vent Obstructed When Hallway Door is Opened**

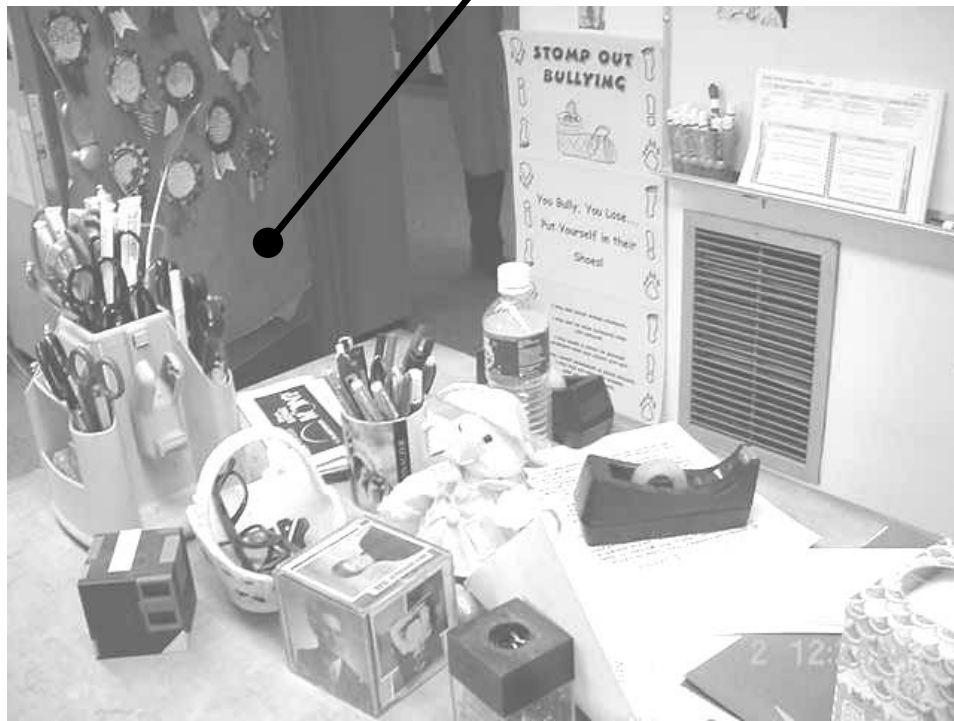
**Picture 5**

**Proximity of Classroom Exhaust Vent to Hallway Door**

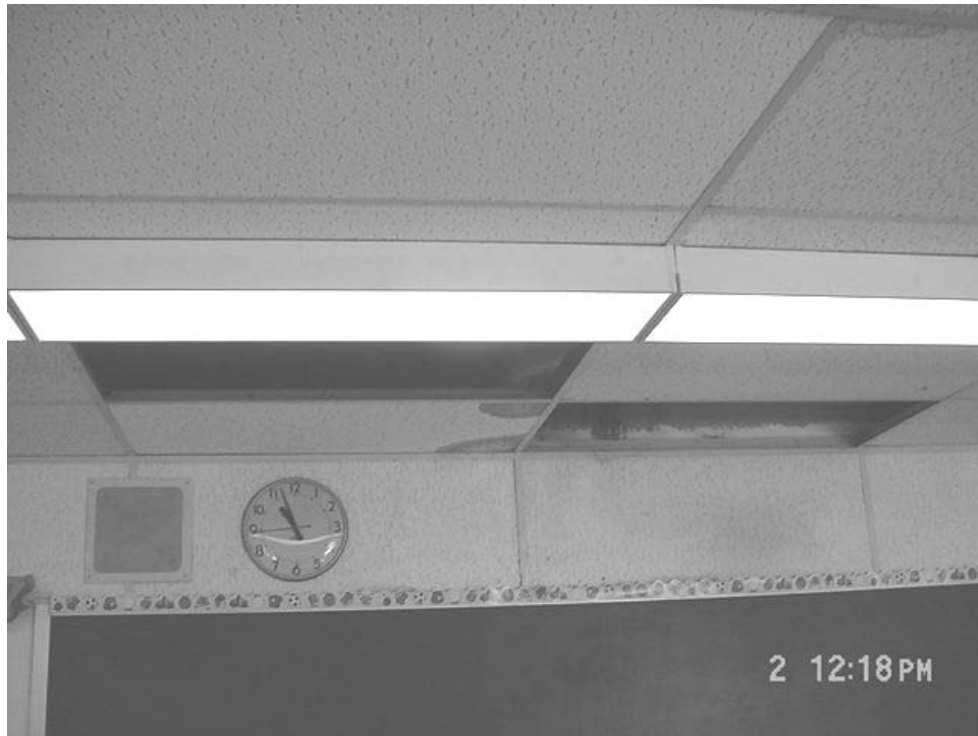
**Picture 6**

**Missing/Water Damaged Ceiling Tiles in Classroom**

1. Continue with plans for roof replacement including the removal of historical “patches”. Once roof is repaired, replace any remaining water-stained ceiling tiles and other water damaged building materials. Examine the area above and around these areas for microbial growth. Disinfect areas of water leaks with an appropriate antimicrobial.
2. Examine the feasibility of enhancing drainage to areas of the roof subject to water pooling (e.g. east wing roof). This may include redirecting the pitch of the roof towards drains or installation of new drains.

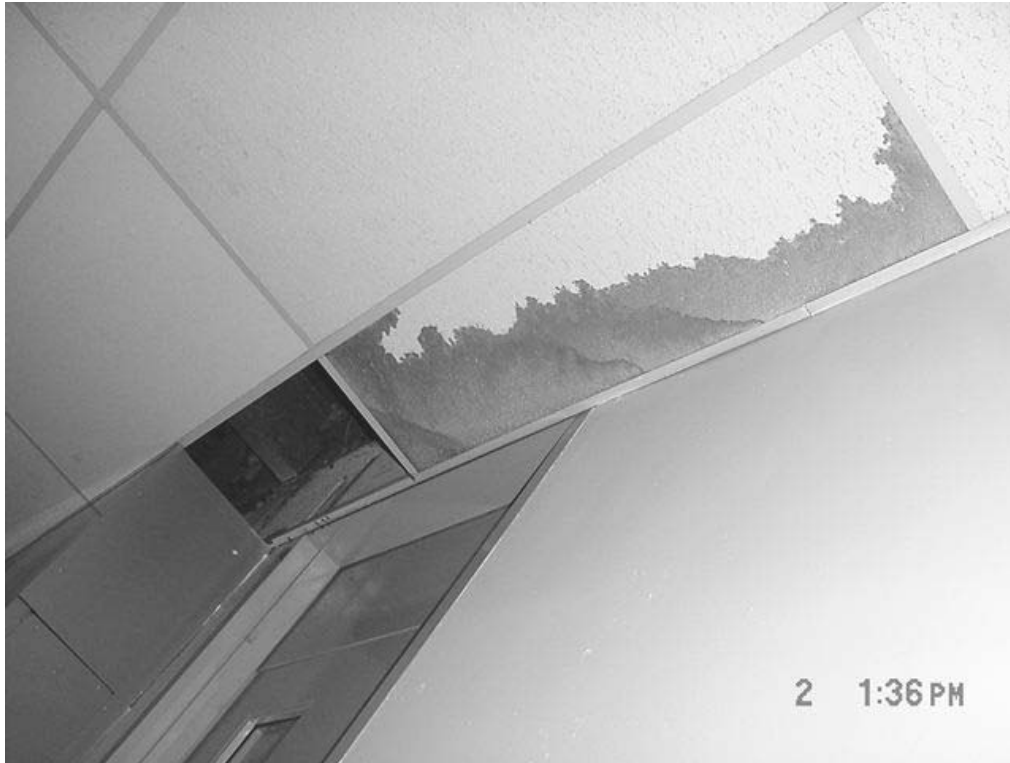
**Picture 7**

**Missing/Water Damaged Ceiling Tiles in First Floor Hallway**

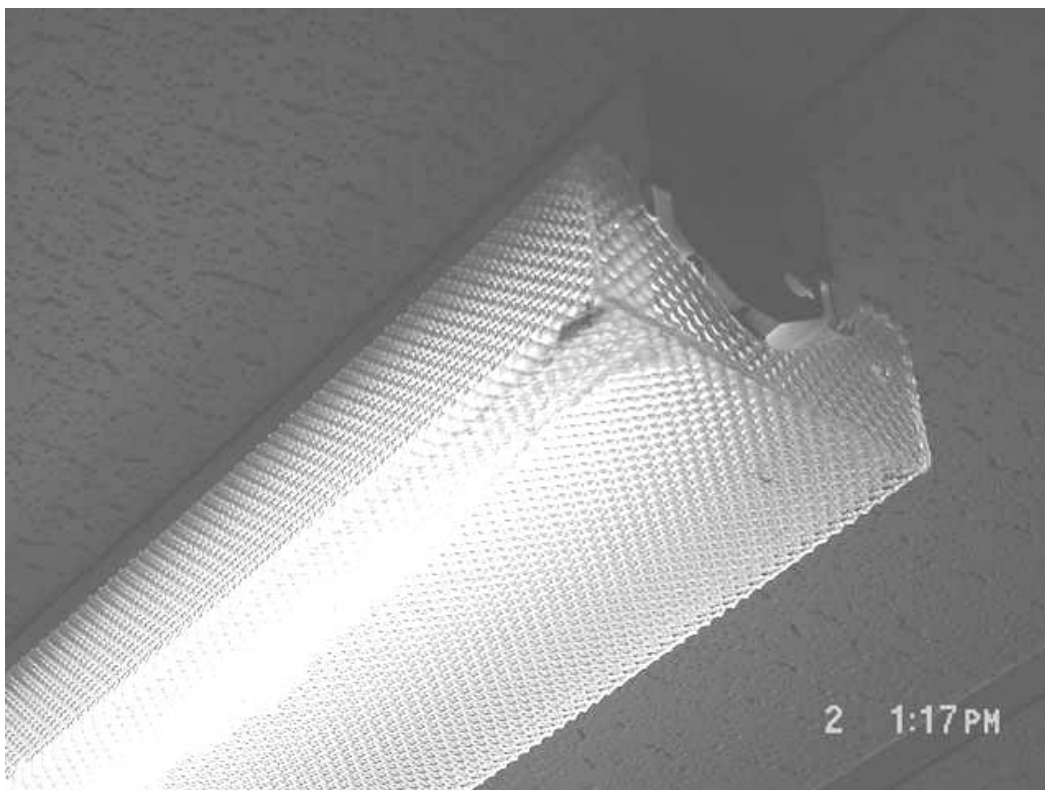
**Picture 8**

**Staining Inside Light Fixture From Accumulated Water**

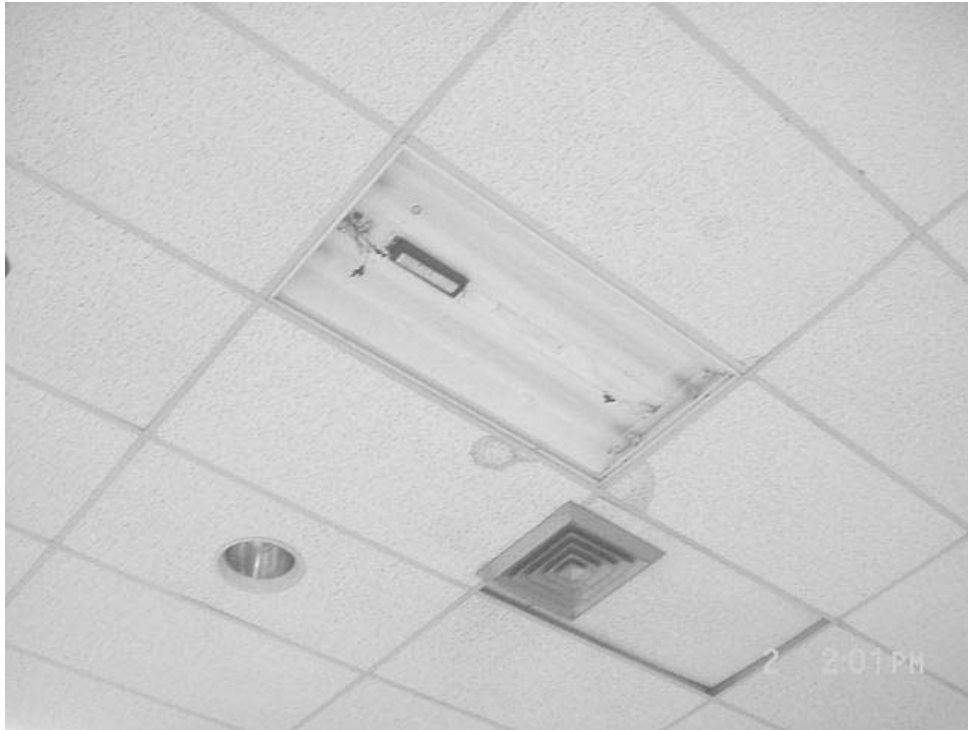
**Picture 9**

personnel have also disconnected electrical utilities and removed light fixtures due to water contact (see Picture 9). Water leakage in classrooms and common areas is collected by buckets, trashcans, tarpaulins and in Picture 10, empty instrument cases. Water-damaged ceiling tiles can provide a source of mold and should be replaced after a water leak is discovered and repaired.

**Light Fixture Disconnected and Partially Removed Due to Water Damage**

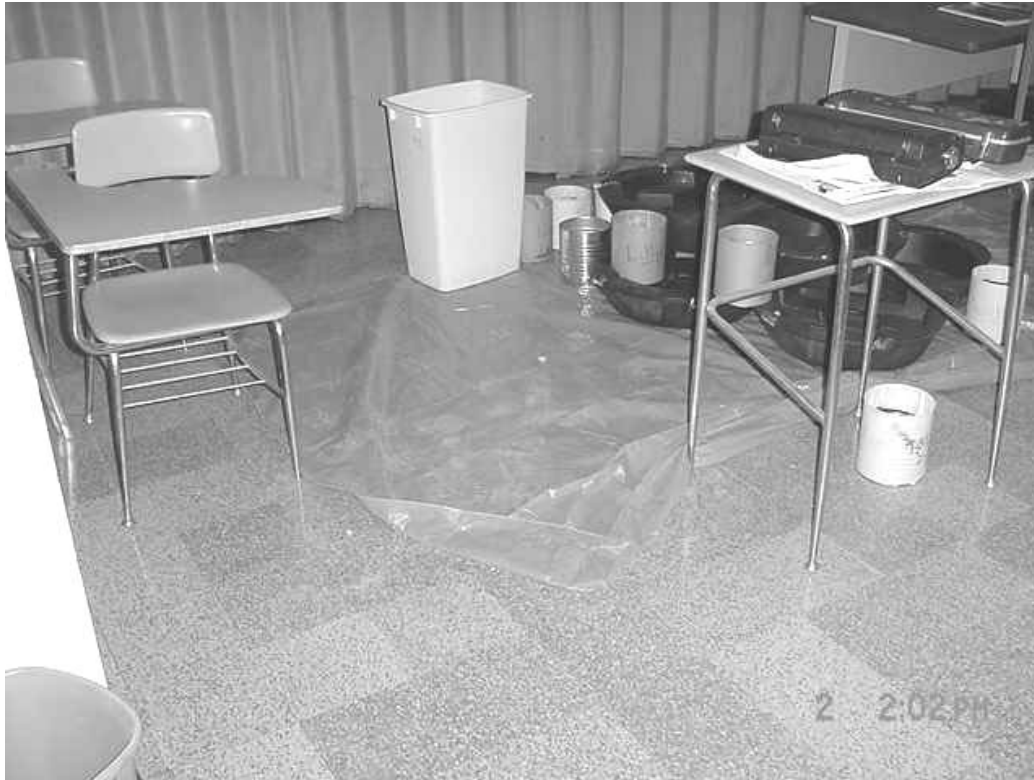
**Picture 10**

**Plastic Sheetting on Floor, Buckets, Trash Cans and Instrument Cases  
To Collect Water Leaks from Roof**

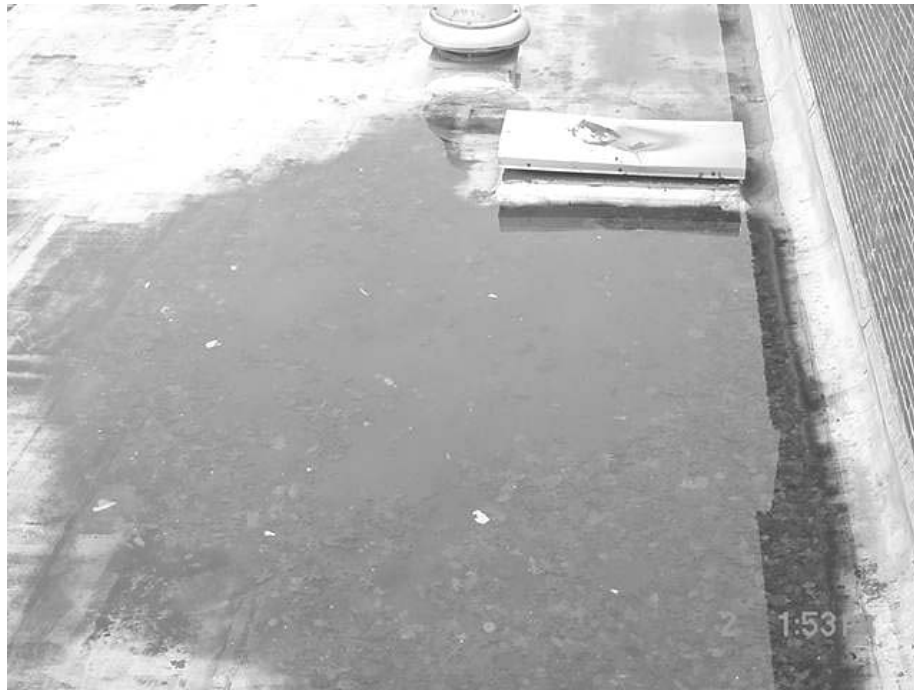
**Picture 11**

Pooling water was observed in a number of areas on the roof (see Picture 11). The freezing and thawing of water during winter months can lead to roof leaks and subsequent water penetration into the interior of the building. Pooling water can also become stagnant, which can lead to unpleasant odors and microbial growth. In addition, stagnant pools of water can serve as a breeding ground for mosquitoes.

**Pooling Water, Leaves and Debris on Roof Near Univent Air Intake**

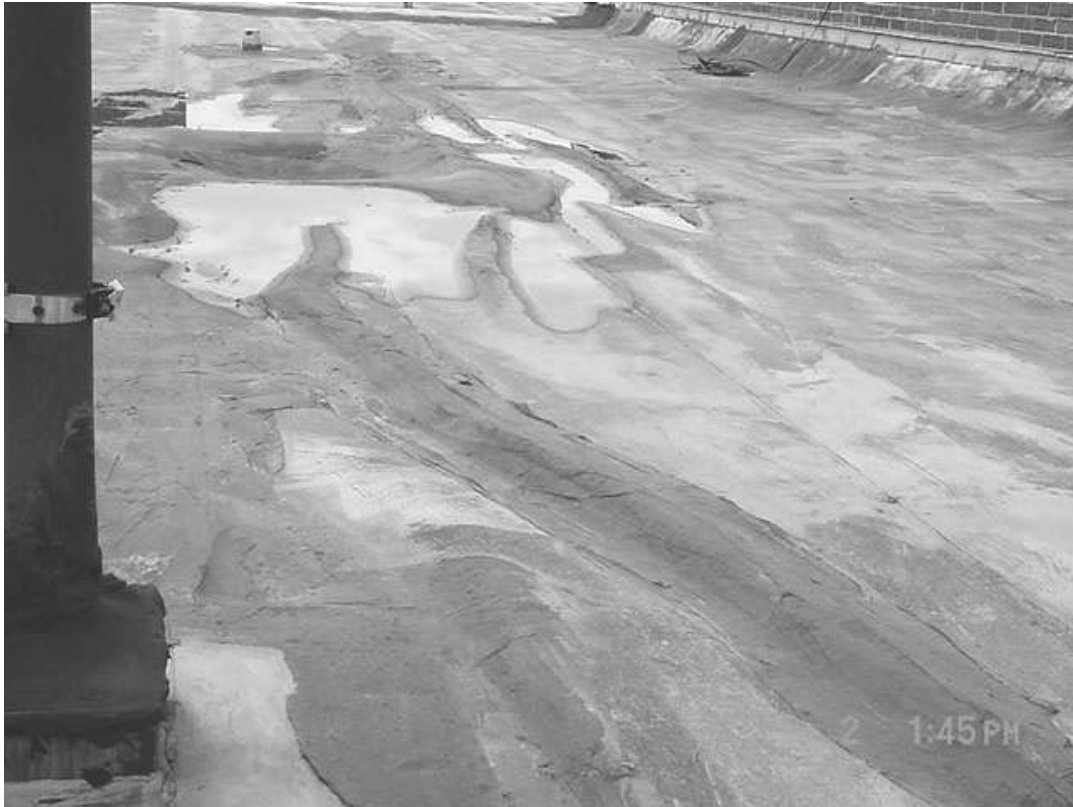
**Picture 11**

BEHA staff examined the roof and found the rubber membrane to be rippled, brittle, and cracked in a number of areas (see Pictures 12-14). This breach of the building envelope that can allow water penetration into the building. It was reported by school officials that attempts were made to repair and replace some sections of the roof. These attempts did not, however remove old damaged roof, but covered the existing roof with new layers of material. School officials reported that plans have been discussed for replacement of the roof; which will include the removal of all existing roof layers.

**Warped, Rippled Roof Membrane, Note Water Pooling Between Grooves**

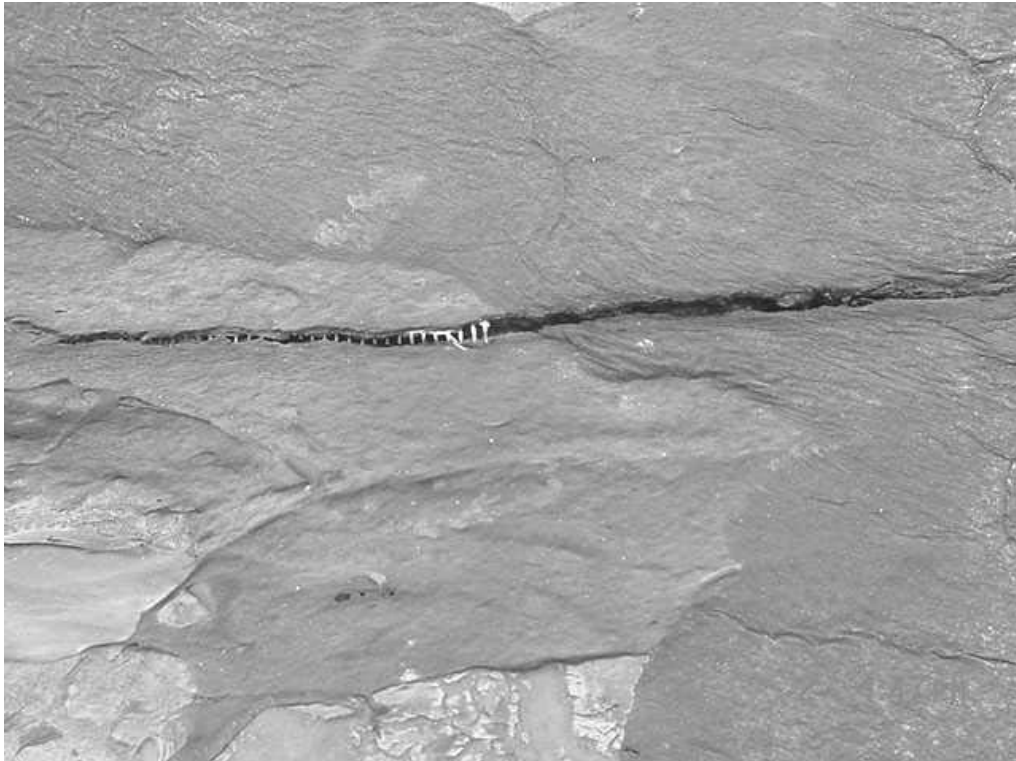
**Picture 13**

**Large Crack in Roof Membrane Exposing Wire Mesh Matrix beneath**

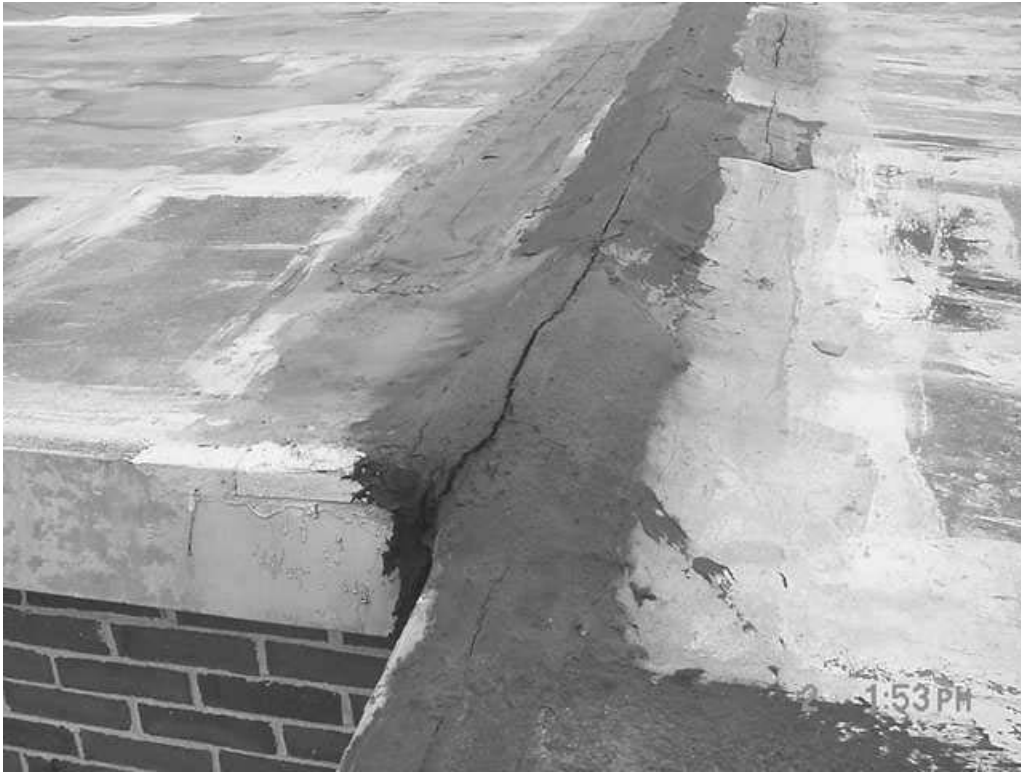
**Picture 14**

**Crack in Roof Membrane That Runs Length of Roof**

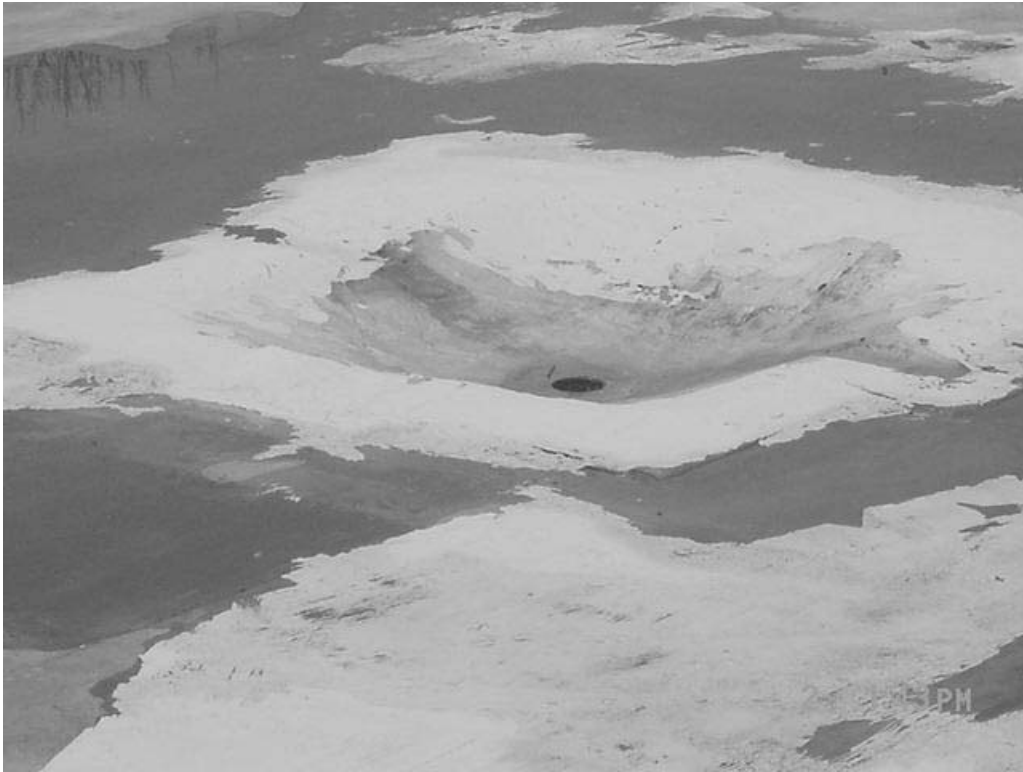
**Picture 15**

Also noted on the roof was the absence of catch basins/strainers around roof drains (see Picture 15), which can allow the drains to become clogged easily. The east wing roof only had three drains, which appeared to be inadequate. Many areas had damaged flashing along roof edges/seams that allow water to accumulate against the building (see Picture 16).

**Roof Drain, Note Lack of Strainer/Catch Basin**

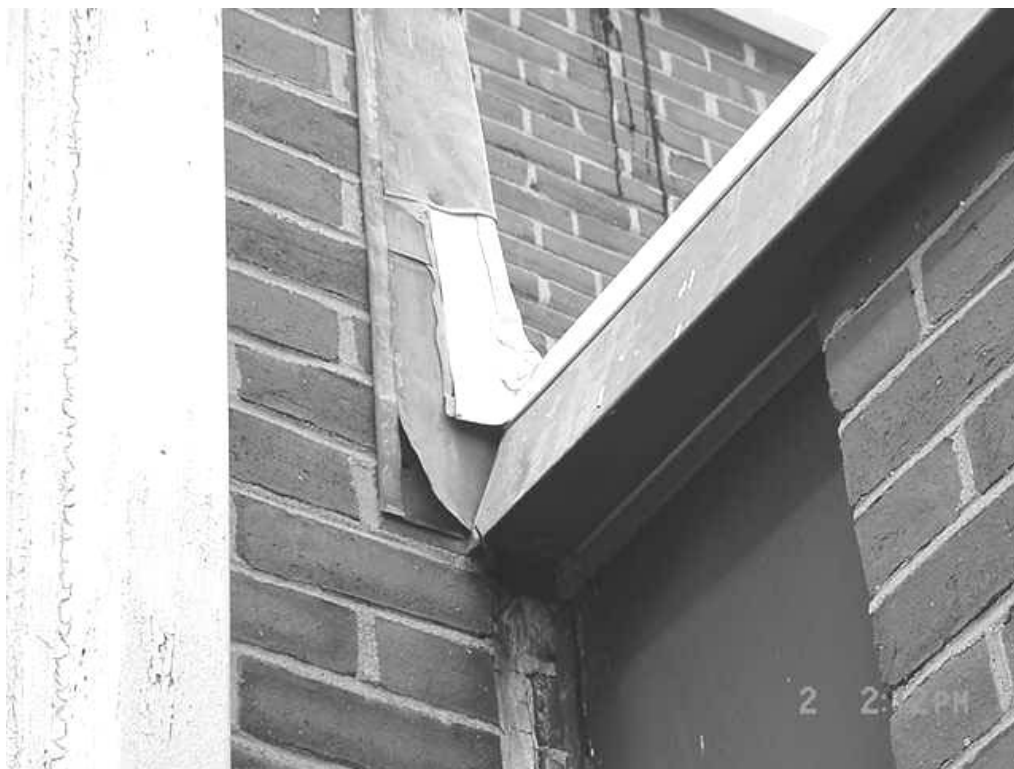
**Picture 16**

**Damaged Flashing Along Roof Junction**

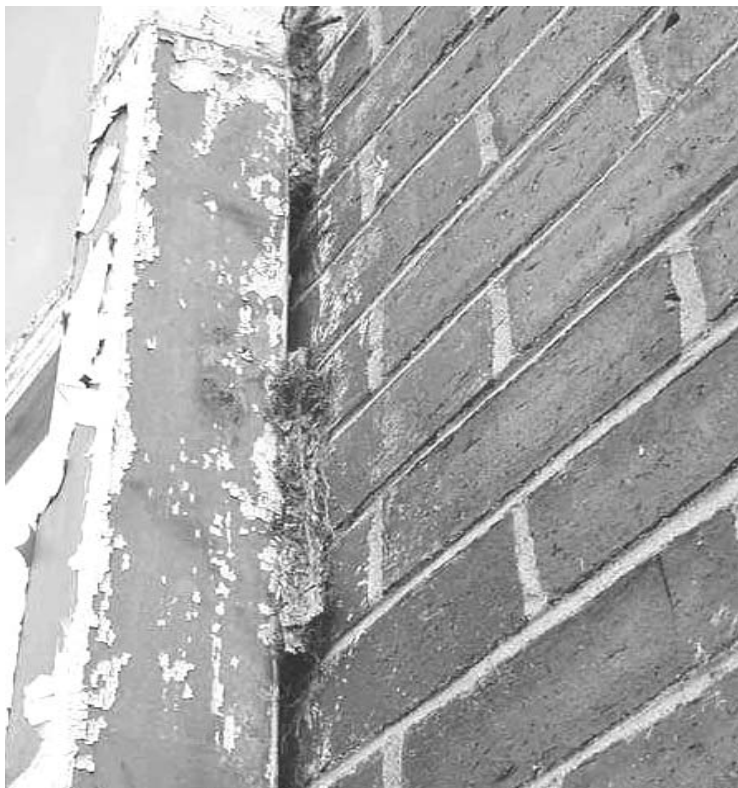
**Picture 17**

Exterior caulking around windows and frames was crumbling/damaged in a number of areas and condensation was noted between windowpanes indicating that the water seal is no longer intact (see Pictures 17-19). A probe was inserted approximately six inches into the space around a classroom window frame, to demonstrate a potential pathway for wind driven rain to enter interior wall space (see Picture 20). Replacement of caulking and repairs of window leaks are necessary to prevent water penetration. Repeated water damage can result in mold colonization of porous building materials and items stored on or around windowsills. Missing/damaged caulking around univent air intakes was also noted, which can provide another source of water penetration as well as pest migration (see Picture 21).

**Missing Damaged Caulking around Window Frame**

6. Repair/replace loose/broken windowpanes and missing or damaged window caulking building-wide to prevent water penetration through window frames. During this project it is recommended that all water-damaged materials be examined for microbial growth and structural integrity. Repair water damaged ceilings, walls and wall-plaster as necessary.

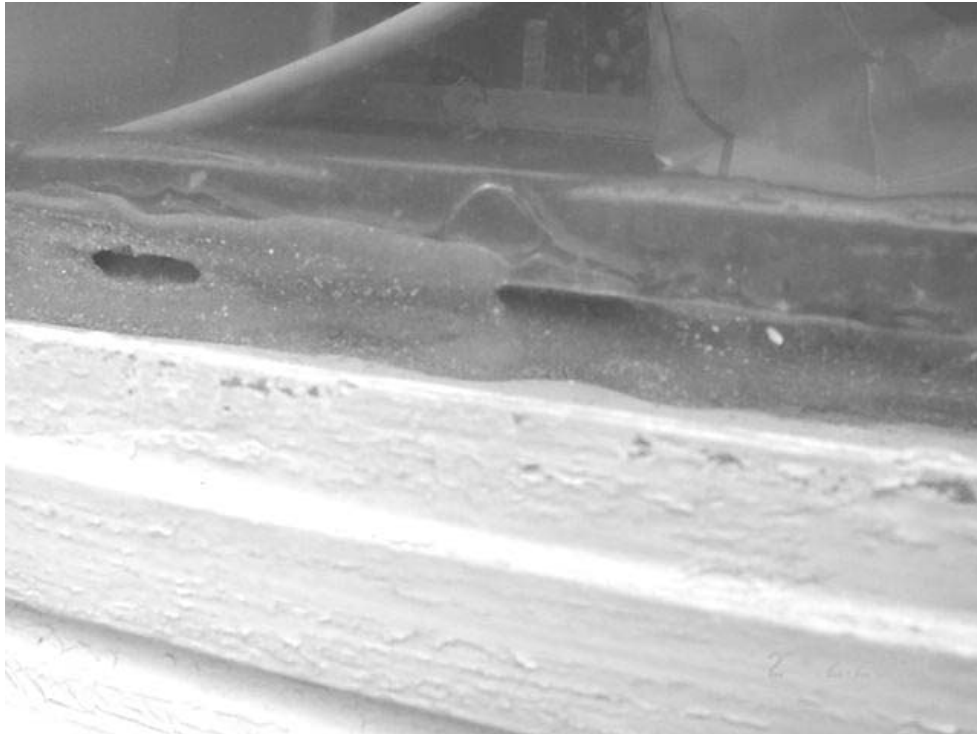
**Picture 18**

**Missing Damaged Caulking around Window Pane, Note the Bottom of Glass Exposed**

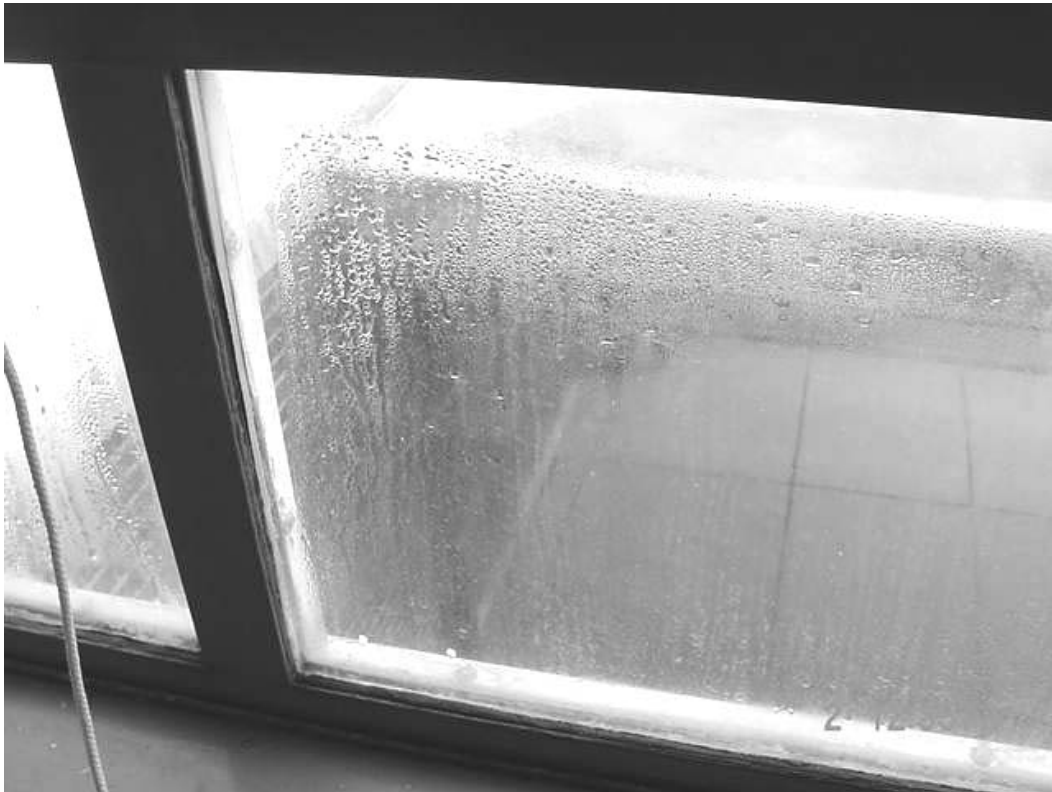
**Picture 19**

**Condensation Between Double Paned Windows in Classroom**

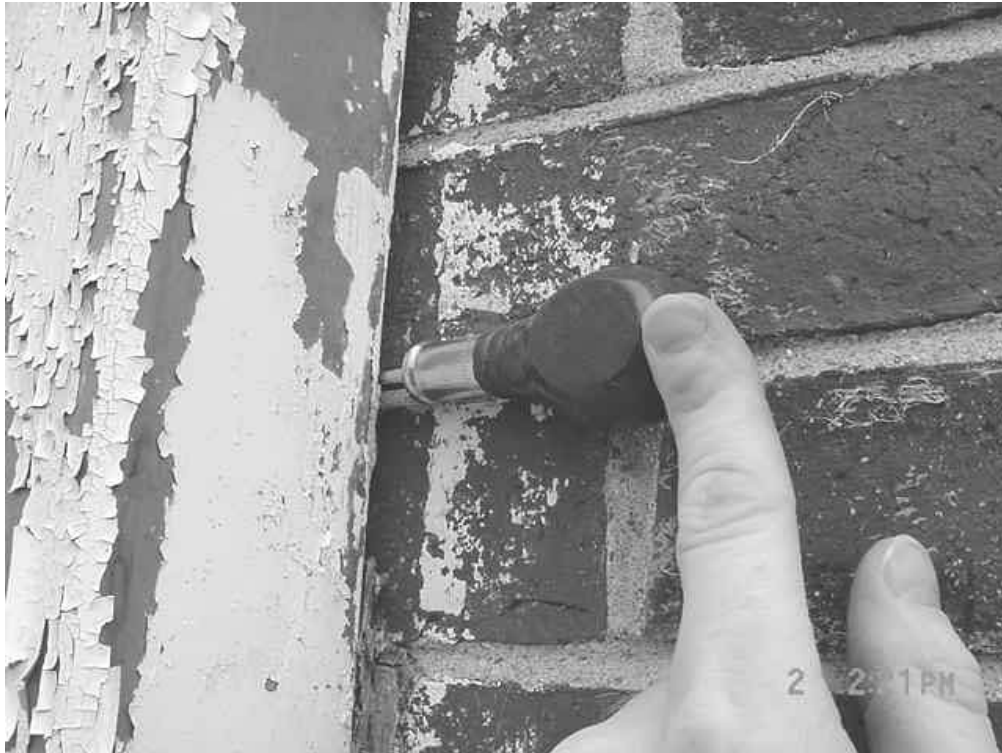
**Picture 20**

**Probe Inserted Into Space around Window Frame Missing Caulking**

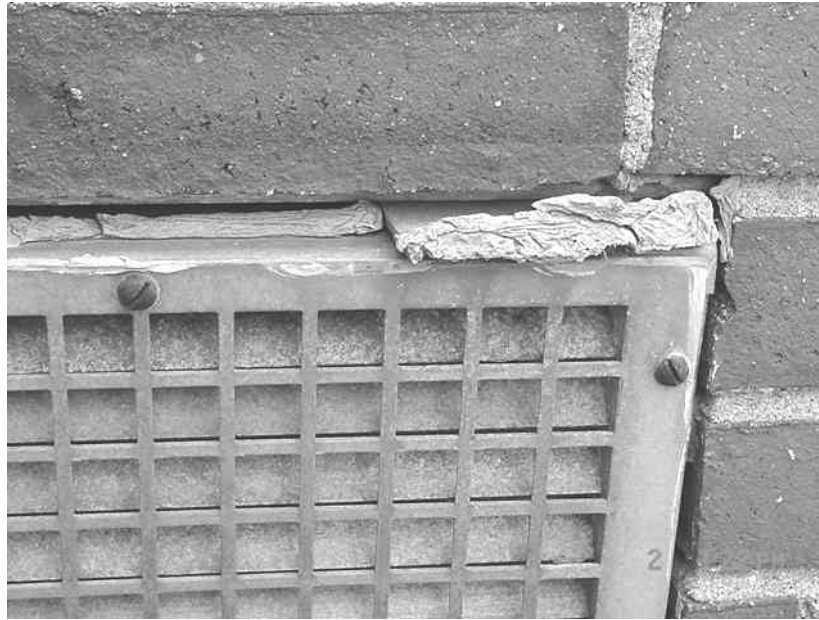
**Picture 21**

**Missing Damaged Caulking around Univent Air Intake**

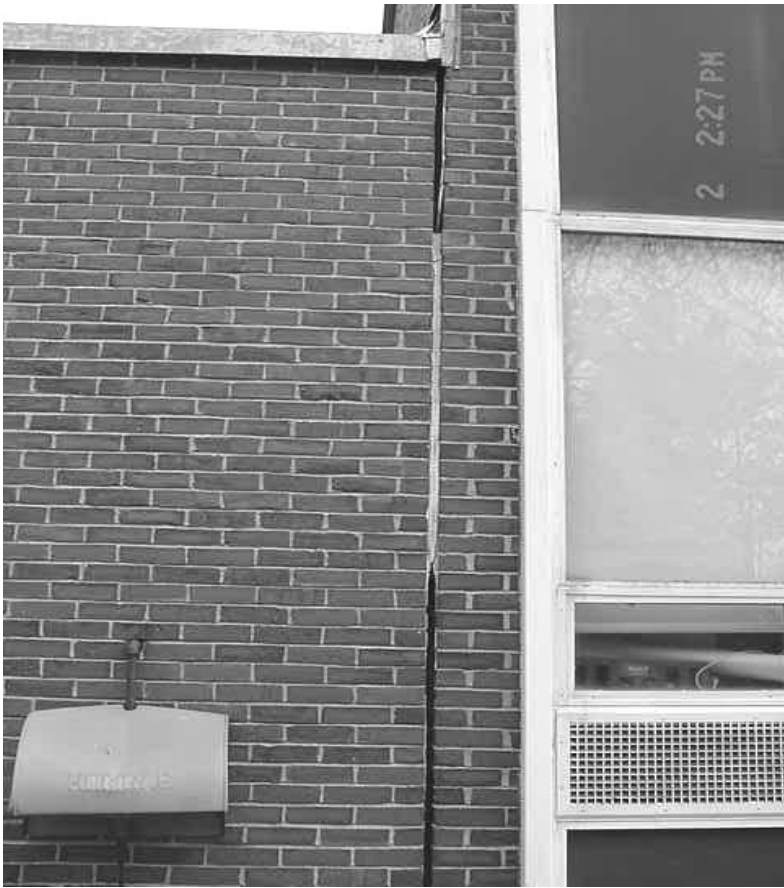
**Picture 22**

Expansion joints around the exterior of the building may also be contributing to water penetration. A sealant compound was inserted into each joint to prevent water penetration. Expansion joint sealant was weathered, mechanically damaged or missing. (see Pictures 22 & 23). Sections of missing or damaged expansion joint sealant can serve as means for water entering during driving rains. These breaches can also allow for entry of insects, rodents and other pests into the building.

**Missing/Damaged Expansion Joint Sealant**

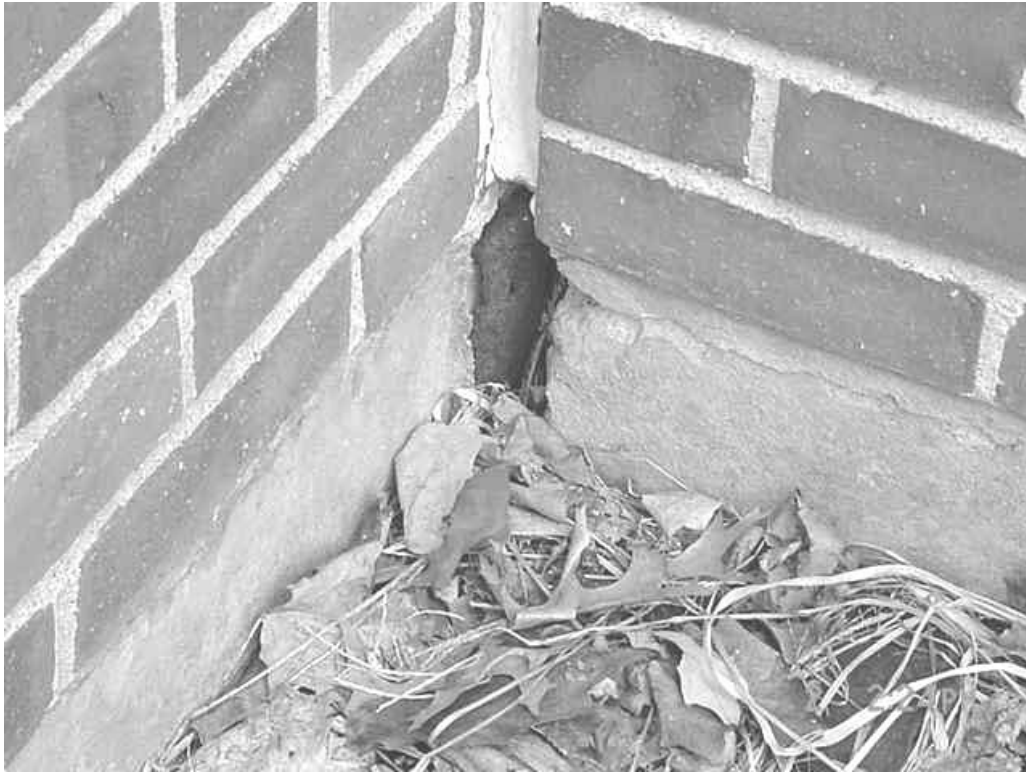
**Picture 23**

**Missing/Damaged Expansion Joint Sealant, Note Large Hole in Foundation  
Can Provide Entry for Pests**

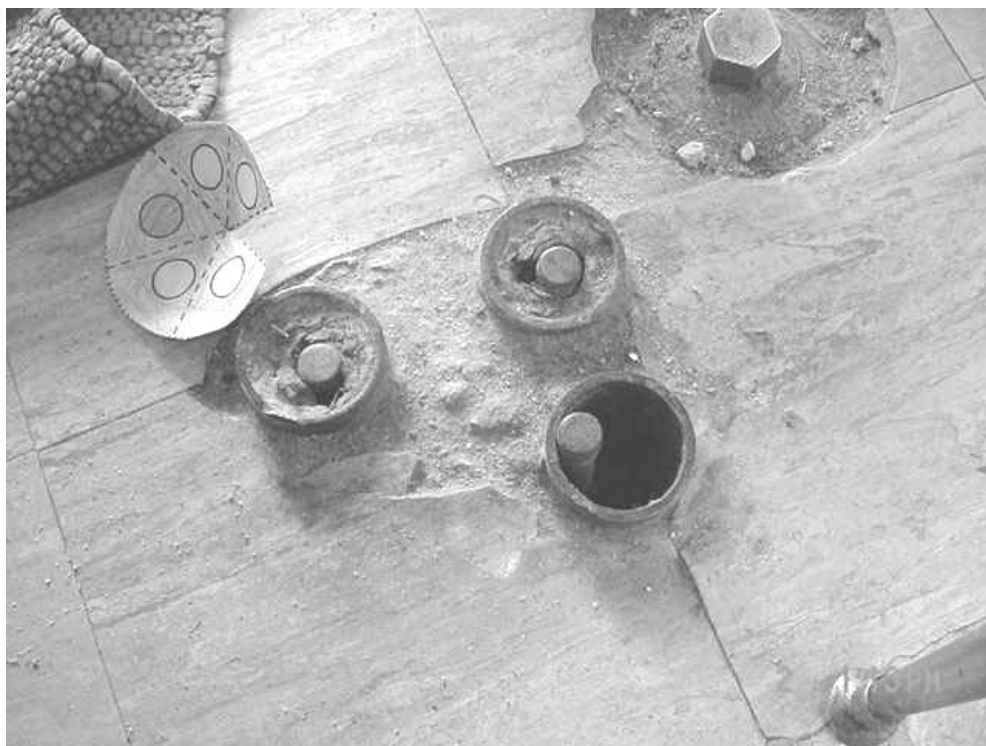
**Picture 24**

Open utility holes were noted in a number of areas (see Picture 24). Open utility holes can provide a pathway for the movement of drafts, odors and particulate matter between rooms and floors.

**Open Utility Holes in Floor of Classroom 106**

11. Remove plant growths against the exterior wall/foundation of the building to prevent water penetration.
12. Seal utility holes in classrooms, to prevent the egress of odors and particulate matter into classrooms.
